NIMROD LAKE AN ARCHEOLOGICAL SURVEY OF A RESERVOIR
DRAWDOWN(U) ARKANSAS ARCHEOLOGICAL SURVEY FAYETTEVILLE
T L LEATHERMAN 1978 RR-22 DACW03-78-M-1252

Arkansas Archeological Survey Research Rpt. No. 22

Nimrod Lake

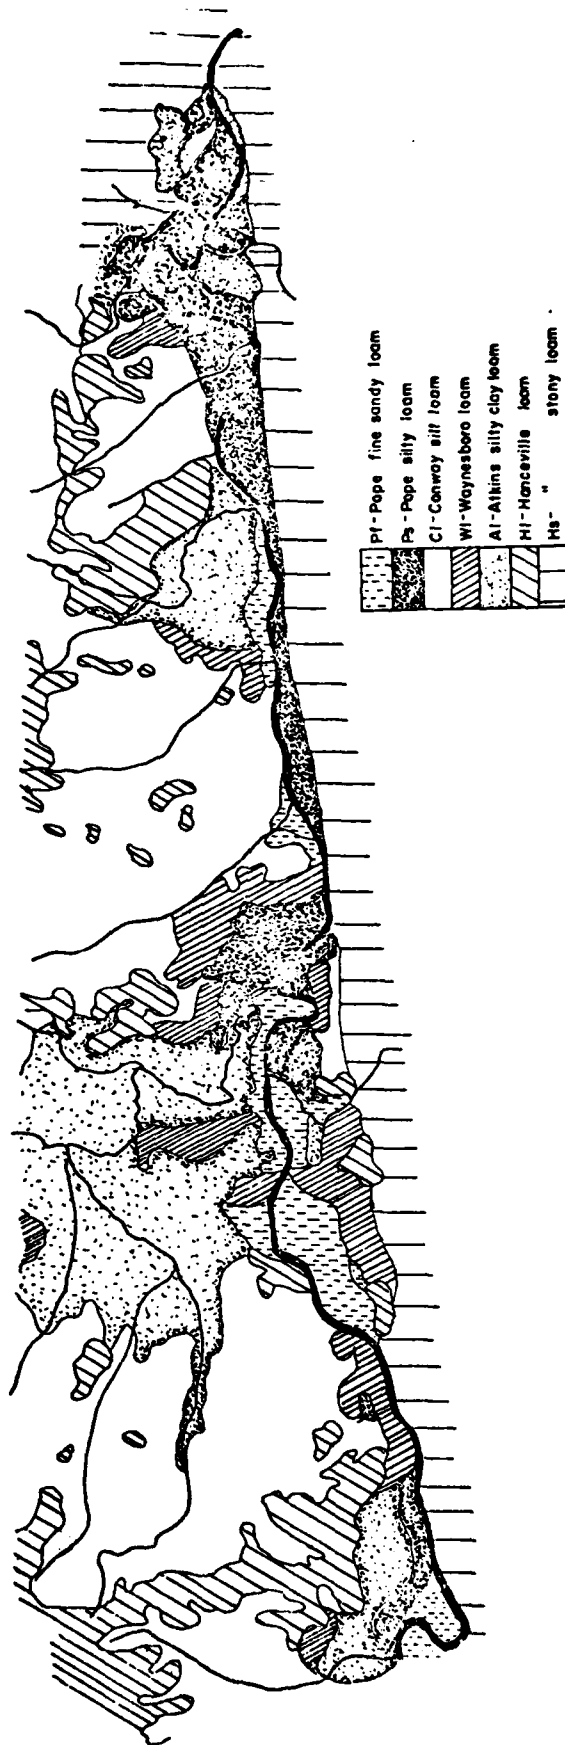
Figure 6. Soils associations at Nimrod Lake.

First Terrace Soils.

Pf--The Pope fine sandy loam typically consists of a brown fine sandy loam which has a relatively homogenous character to depths of 10-30 inches, where lighter brown to yellowish fine sandy loam, clay loam, or sandy clay is observed. Within Yell County the most important areas of this type occur along the Fourche La Fave River and in continuous strips along many of the smaller streams. The type occurs in the first bottoms of streams, largely along the

Al--The Atkins silty clay loam is a mottled dark gray and brown or rusty brown silty clay loam, running 2-3 inches and then passing abruptly into a light brown to bluish gray silty clay loam, which at 12-15 inches passes into a mottled gray and brownish yellow silty clay. The Atkins silty clay loam is developed mainly in the bottoms of the Fourche La Fave River with a few areas along the larger tributaries. It is closely associated with the Pope silt loam, likewise formed from wash of sandstone and shale soils. Characteristically, it occupies flat, poorly drained areas, situated some distance from the stream banks. Overflows occur but are of short duration, although many depressions of long standing water can be observed. This is a strong soil which should preferably be artificially drained for cultivation.

Wf--The surface soil of the Waynesboro fine sandy loam is a brown to reddish brown fine sandy loam 8-10 inches deep. The subsoil is a deep red to brownish red fine sandy clay, which becomes somewhat lighter red in the lower part of the 3 foot section, and grades at about 15 inches into red or yellowish red fine sandy clay. Rounded and angular pieces of sandstone are found here and there on the surface and through the soil masses.

The soil associations found at Lake Nimrod reflect the composition and relative weathering potentials of the sandstone and shale bedrock in the vicinity. There is a predominance of silt loams with variable gravel and stone content, and several sandy loams. The soil maps which were used in identifying the soils associated with the project area were drawn before creation of the reservoir (Figure 6; Deeter and Lounsbury 1917; Deeter et al. 1923). Updated versions of these maps are still in process and would lack identification of soils within the reservoir which are covered at conservation pool level.

The residual soils are generally found in the uplands or in gently rolling areas of valleys. The upland soils traversed in the Nimrod survey are residual soils formed from weathered sandstone and shale. The alluvial soils of this area are washed from the sandstone and shale upland soils.

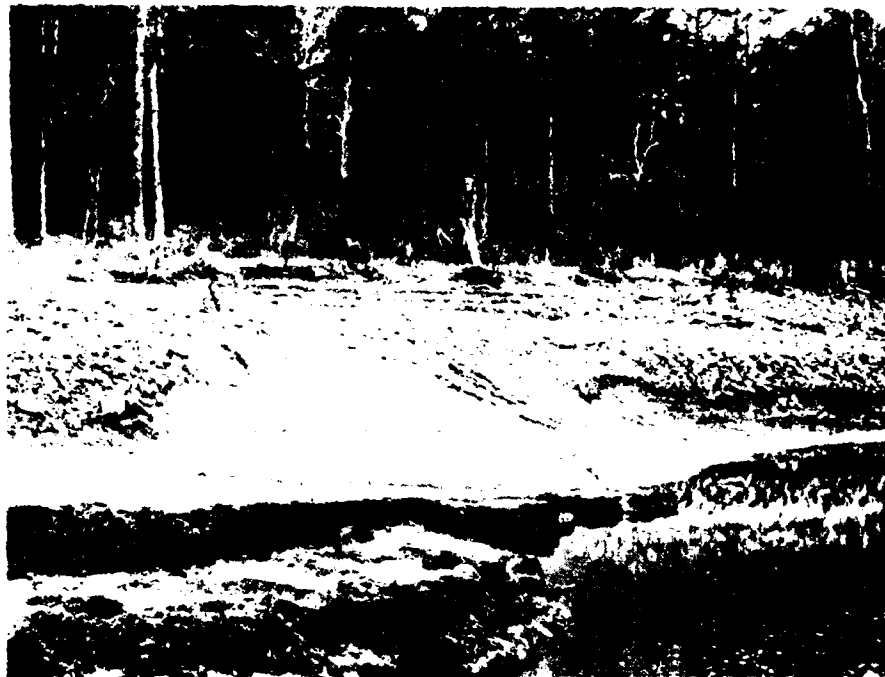
Figure 8. Terracing, cutting, and slumping of river channel at Nimrod Lake

On the south side of the lake and at the upper end of the reservoir where the reservoir is confined to the river channel and the gradient is much steeper, other factors in addition to wave action may result in bank slumping. An increased water flow in the reservoir would create turbulence which causes sediments to be carried from banks, in effect undercutting the bank, and a subsequent lowering of pool elevation would result in the bank caving in (Leopold et al. 1964). A rapid decrease in pool elevation such as occurs during drawdowns would alter the pressure between the channel or pool's hydrostatic pressure and the adjacent saturated bank, also resulting in caving or slumping of the bank. Slumping of the terrace banks along the river channel, especially at the west end of the reservoir, was repeatedly observed during the survey of the Nimrod Reservoir (Figure 8).

It is recommended that areas with erosional tendencies be monitored during future drawdowns or at low water levels to assess the degree of ongoing site destruction. The careful control of pool fluctuations could possibly decrease the extent of future erosion. Finally, it is highly recommended that more effective measures be taken in dissuading the public from the unauthorized collection of archeological sites on this COE property. Two suggestions offered with respect to that recommendation are (1) education of the public and (2) strict enforcement of laws pertaining to cultural resource protection especially in the early stages of drawdown.

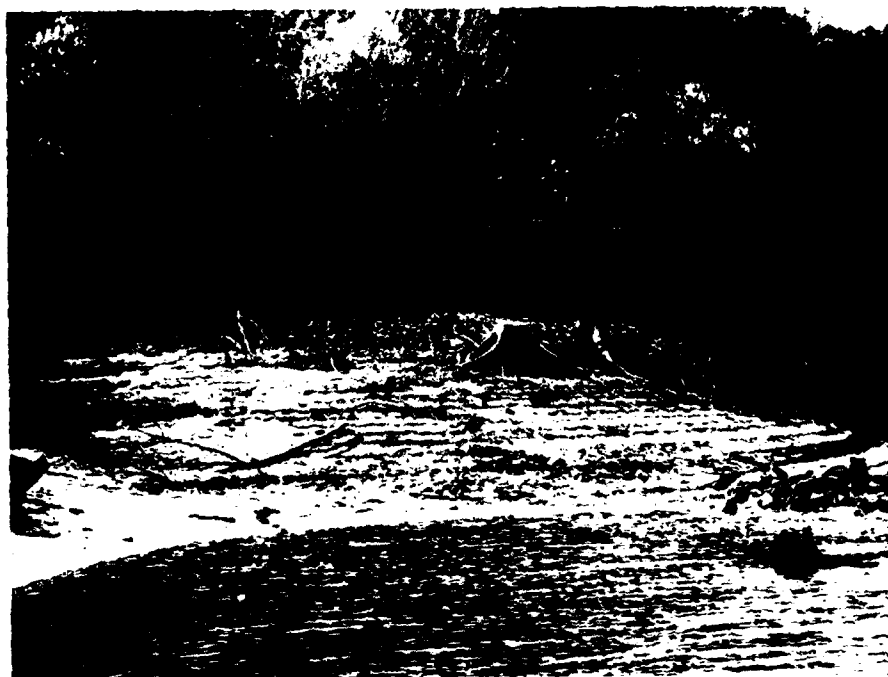
Figure 9. Terracing along meander channel at Nimrod Lake

Drawdowns staged for water and fish management constitute a special type of pool fluctuation. During drawdowns the rapid decrease of the pool level contributes to terrace cutting and slumping. In several areas along the shoreline a terracing effect was observed and thought to be the result of artificial pool levels created during the drawdown (Figures 8 and 9). The exposure of the lake bottom results in drying and cracking of surface soils and artifacts. Ceramic materials are particularly affected by this process. Even in the controlled conditions of a laboratory, saturation of ceramics with water and subsequent drying may effectively erode the sherd matrix. Soils exposed during a drawdown may consequently become more unstable and undergo some sediment loss through suspension of dry soil particles as the lake rapidly refills.

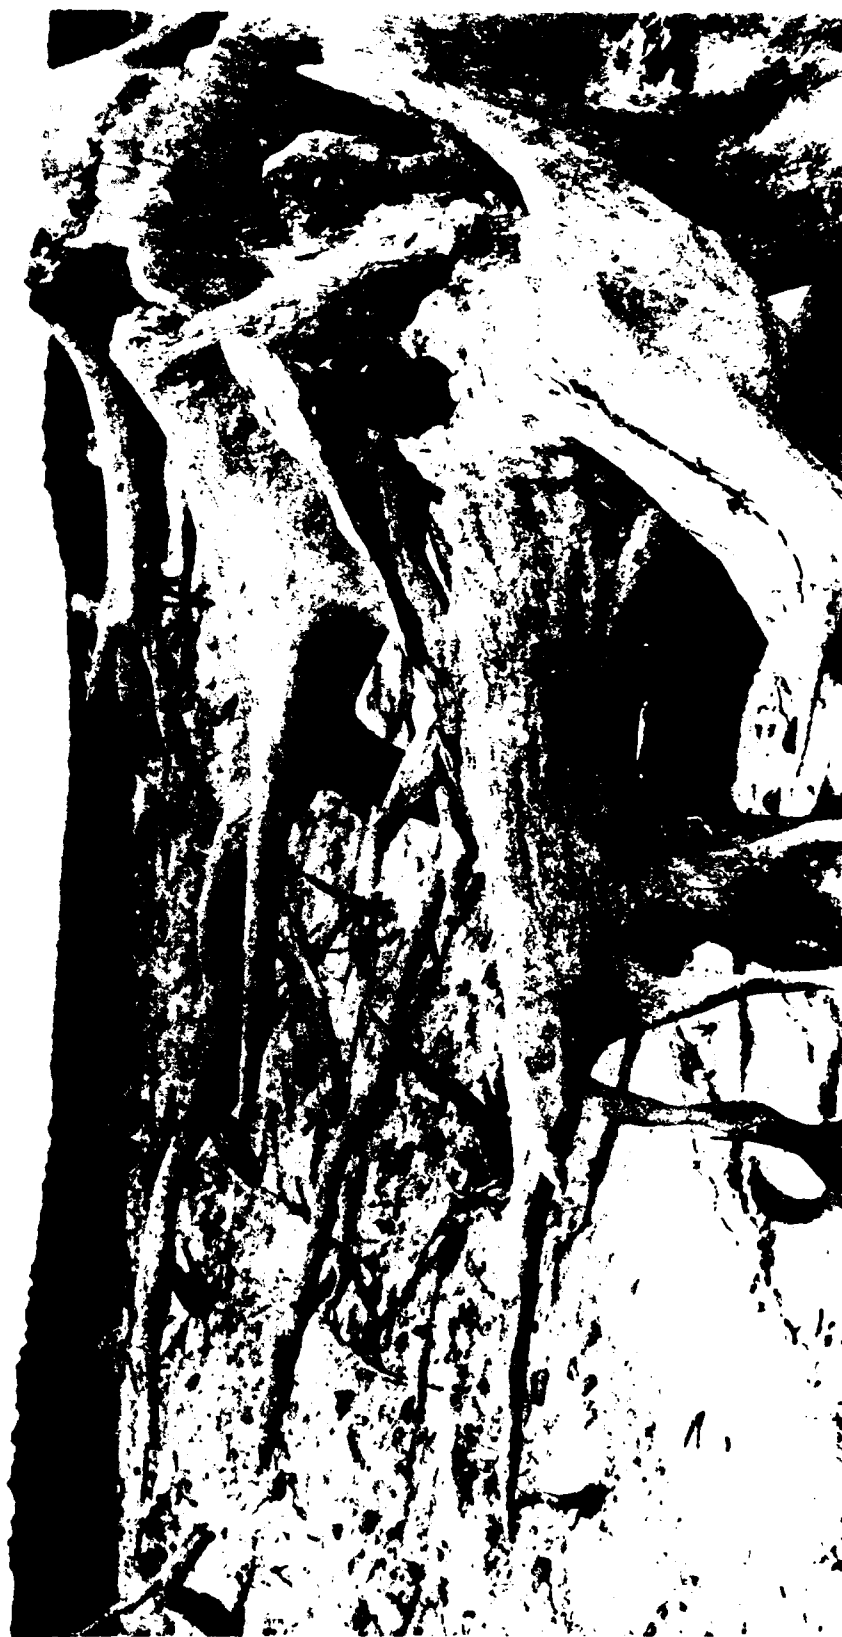
Within the more level floodplain of the Fourche La Pave most erosion was noted along river or stream banks. Tree stumps frequently marked terrace edges, and the most obvious signs of erosion were the exposed root systems of these stumps (Figure 10). The erosional processes in operation are analogous to those of bank cutting; pool fluctuation and flooding cause turbulence which

Figure 10. Exposed tree roots along a stream terrace edge at Nimrod Lake.

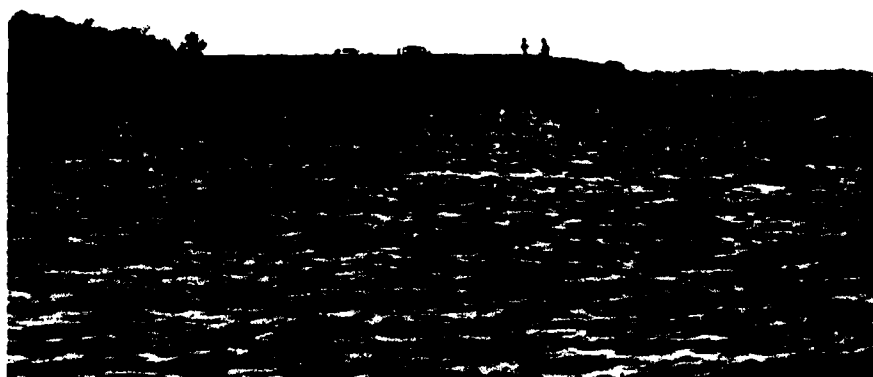
Figure 12. Unauthorized collectors at site 3YE149.
